TECHNICAL SERVICE BULLETINS

**SERVICE BULLETIN****APPLICABILITY:** STi Vehicles, All Model Years
SUBJECT: Towing Recommendations**NUMBER:** 01-162-05
DATE: 06/28/05**INTRODUCTION**

APPLICABILITY: All Models
SUBJECT: Cylinder Head Gasket (residual carbon deposits and rubber coating removal)

NUMBER: 02-100-06R
DATE: 10/31/06

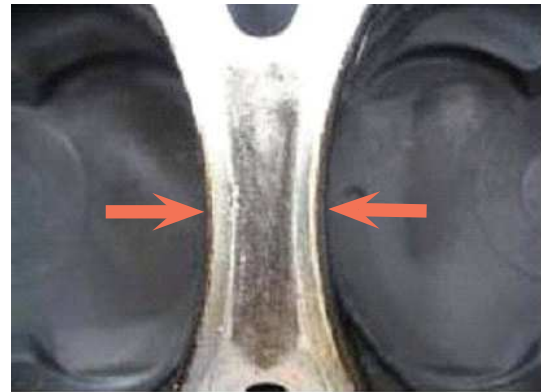
Carbon deposit on cylinder block
bore sealing portion

Using a gasket scraper, carefully clean any carbon deposits and rubber coating found on the surface of cylinder block and cylinder head.

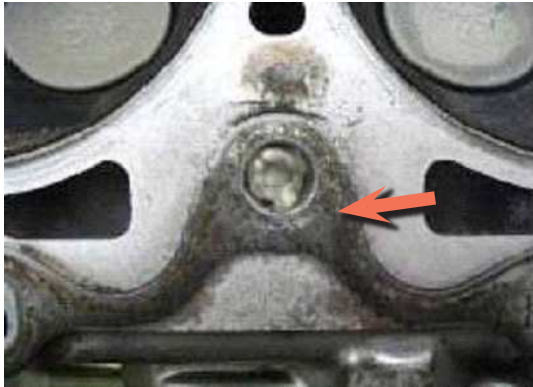
Rubber coating residue on coolant sealing portion

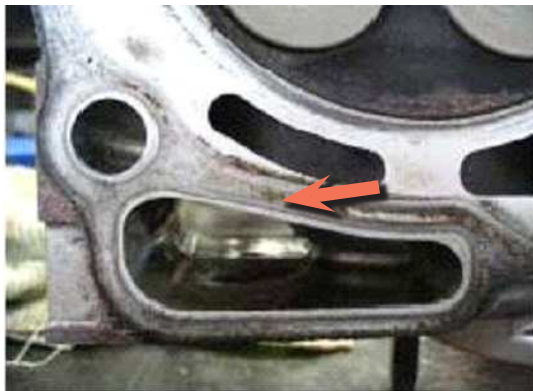
Rubber coating residue on oil sealing portion

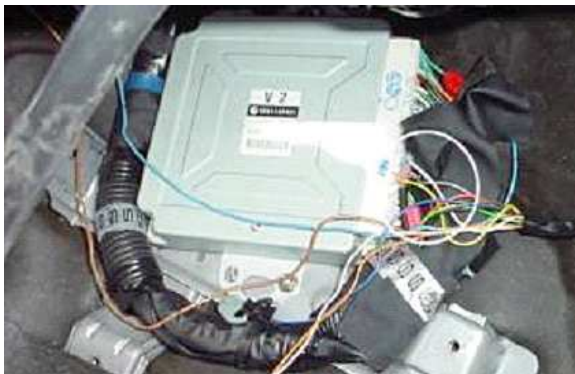
Modifying the engine tuning of a Subaru to increase horse power by Engine Control Unit (ECU) replacement or reprogramming can lead to engine failures. Other external engine modifications, such as intake or exhaust systems, can also lead to failures. Any modifications can reduce engine durability and cause reliability deterioration.

Aftermarket Air Fuel Controller wired to ECM

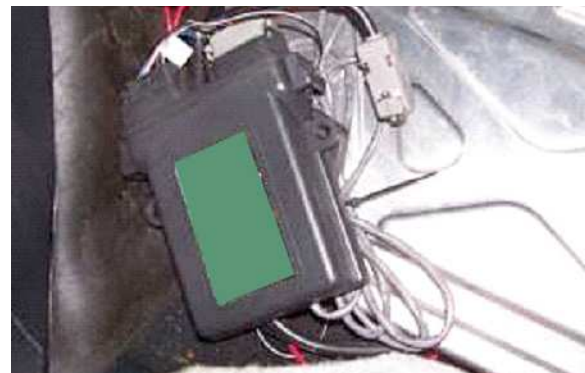
Aftermarket Chip Processor

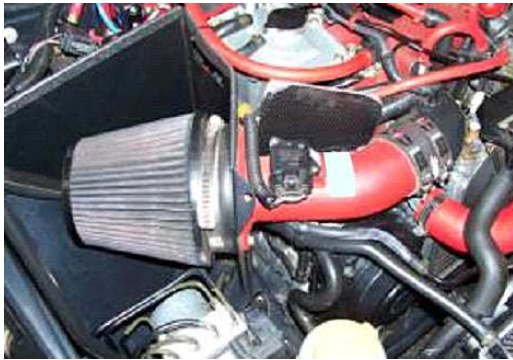
- Allow foreign objects to enter the engine.
- Change the Air/Fuel mixture ratio, due to the change of intake air amount.
- System malfunctions due to a contaminated air flow sensor.
- Reduced engine durability due to higher horse power that exceeds engine design specifications.
- Turbo charger internal damage from excessive turbine speed.

Aftermarket Cold Air Intake

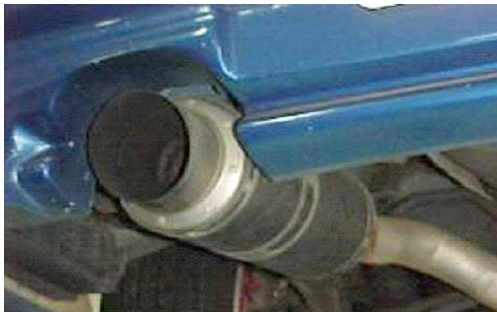
Modifications to the Exhaust System may create a reduction of exhaust resistance. This can lead to similar problems as found in Intake System modifications.

Aftermarket Exhaust System

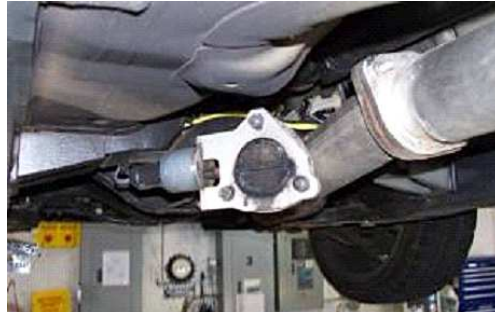
Aftermarket Exhaust Bypass Valve

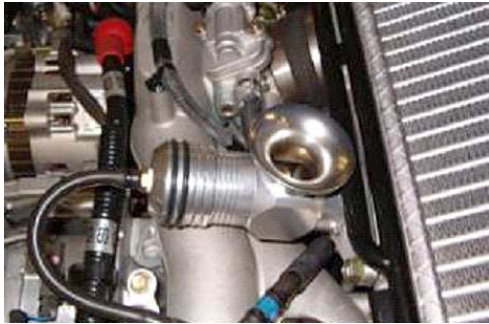
Relocation of any vehicle component may affect the Engine Management System and, in turn, cause potential engine damage.

Aftermarket Blow Off Valve

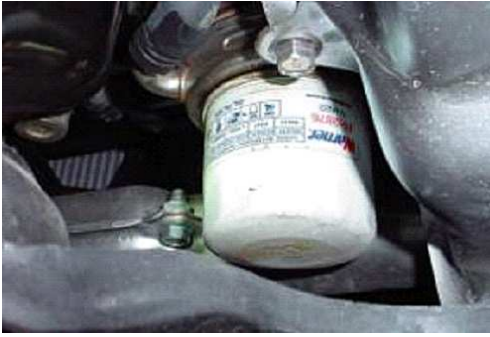
- The use of a Genuine Subaru oil filter is strongly recommended. Many aftermarket oil filters have different filtration capacity and relief valve opening pressure. Those filters may not meet Subaru's requirements and may cause engine problems.

Aftermarket Oil Filter

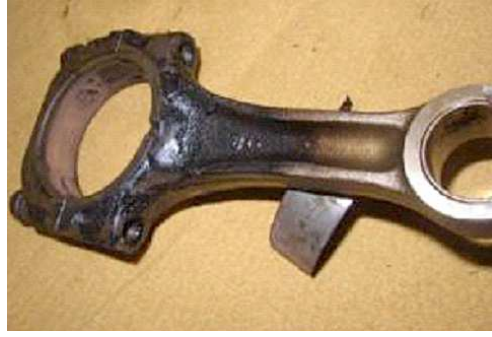
- Some brands of oil which are available in the aftermarket may not have enough lubrication ability and durability, regardless the price. (Poor performance oil causes damage on the crankshaft bearing, camshaft bearing, piston ring, cylinder liner, or turbo charger.)
- If the oil complies with the American Petroleum Institute (API) classification of SM (or SL minimum), and is within the recommended viscosity, it will not cause engine problems.
- A lack of oil may cause damage to the crankshaft bearing, camshaft bearing, piston ring, cylinder liner, or turbo charger.
- When the vehicle is used under severe driving conditions, moderate to hard acceleration on a somewhat regular basis, the engine oil and filter should be changed every 3,750 miles (6,000 km) or 3.75 months. For additional examples of severe driving conditions, refer to the Warranty & Maintenance Booklet.

Rod Bearing Spun from Lack of Oil

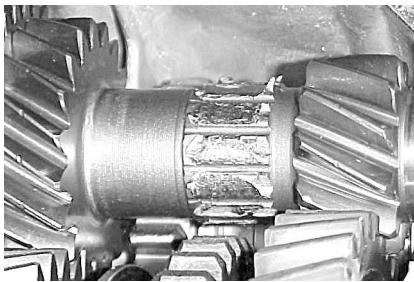
Some examples of abusive driving are exceeding maximum recommended RPMs, excessive torque transferred to the transmission during acceleration from a complete stop (dumping the clutch), downshifting at high RPMs and missing shifts.

Reverse Gear Teeth Stripped

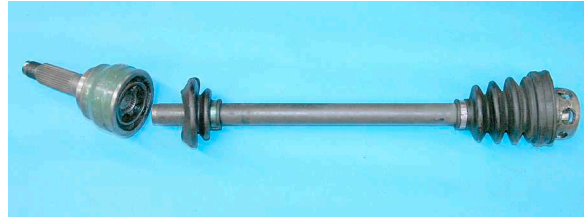
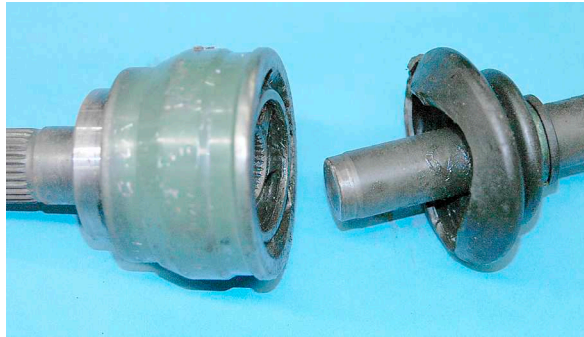
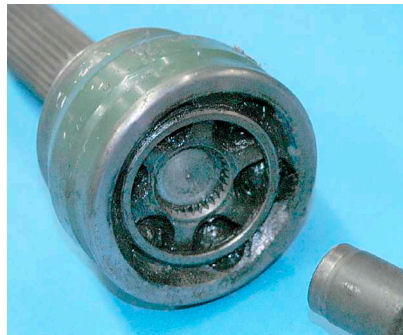
The following 3 photos show an axle shaft that was sheared off at the “Bell Joint” (BJ) as the result of abuse.

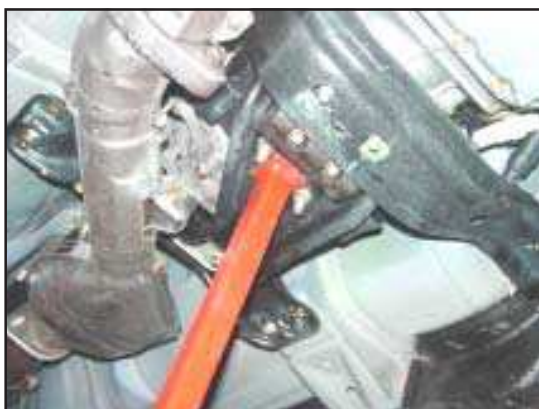
**Figure 1**

When performing service work or installing SOA's accessory short throw shifter, it is extremely important that the transmission is supported properly when removing or reinstalling the cross member. If not, damage to the bolts and/or threads will occur. Support the transmission using a transmission jack, regardless if the vehicle is supported by a lift or car ramps (**Figure 1**). It is recommended that hand tools be used for the removal and installation of the bolts. Inspect for bolt thread damage and replace as necessary. Be sure to clean any protective wax from the mating surfaces and be sure to start all bolts several threads by hand before using tightening tools. **Note: If severe damage is evident to the threads, the use of a Heli-coil® type kit is an approved repair method.**

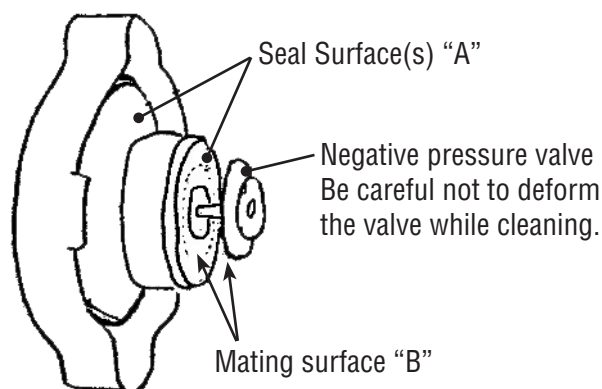
If foreign material is left in the filler neck sealing area, it will become embedded in the rubber seal and will prevent the cap from sealing properly. Before making the determination that the radiator cap is faulty, perform the following repair procedure.

- 1) Wash and clean the rubber seal surface(s) "A" using clean water and a soft bristle brush.
- 2) Carefully open the negative pressure valve. Using clean water and a soft bristle brush wash and clean the mating surface "B" between the valve and the rubber seal.

Note: Clean thoroughly. Failure to do so will prevent the cap from holding pressure.

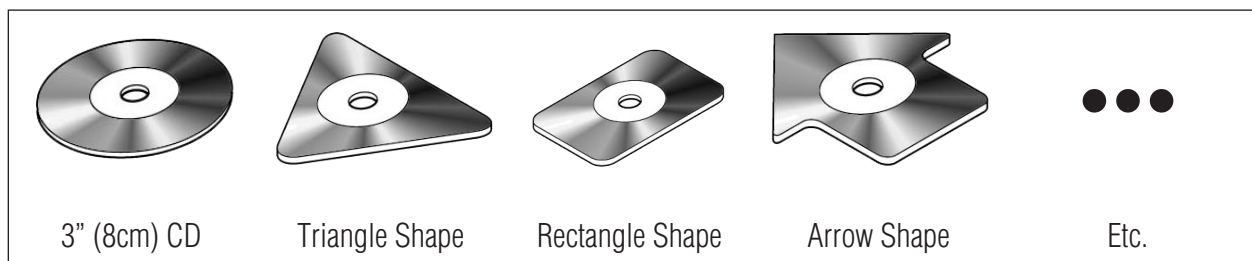
1. Small size, irregularly shaped discs.

The following CDs may cause problems when loading, playing, or ejecting due to the complexity of your CD player's internal mechanisms.

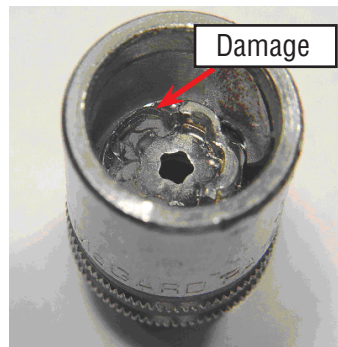
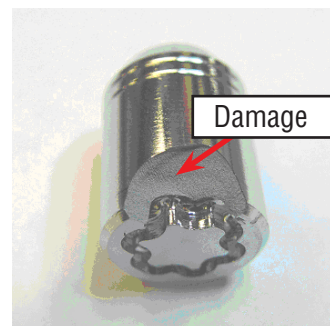
WARNING: Use of an impact wrench may cause permanent damage to the wheel lock and key.

NOTE: For ease of installation and removal, the wheel lock should always be the last lug nut tightened on each wheel and should always be the first one removed.

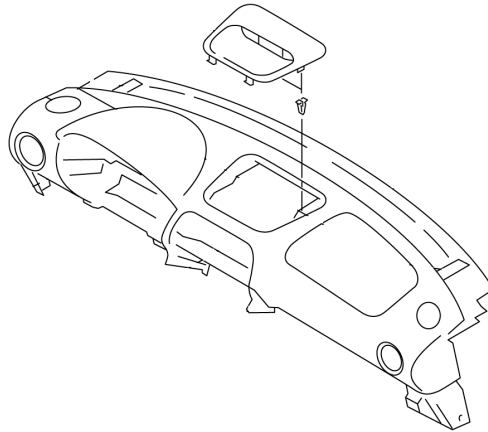
Check the part number of the clock currently installed in the vehicle. If equipped with the old style, replace it with the new style.

- 1) Record radio stations.
- 2) Disconnect negative battery cable
- 3) Remove the clock by carefully lifting up on the clock cover and disengage the 2 front clips.
